Borehole Drilling in South Sudan, 2009

This case study notes the problems encountered in the drilling of boreholes in order that similar problems may be overcome before any further drilling takes place.

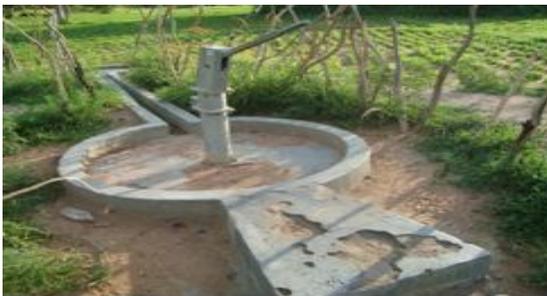
- *In some boreholes the plain casing and screen installation was not properly installed and this has made the removal and fixing of the pipes difficult in case of any technical fault which needs repair by the community hand pump mechanic.*

- *Some boreholes were supposed to be fitted with special components, but not all the parts were fitted as per the contract. Without these components, the water cannot be extracted adequately.*

New borehole – broken after two weeks

- *Tearfund WASH staff should monitor the drilling processes closely so that all the casing, grouting, packing, and platform installations are properly placed and pump testing is carried out adequately.*

- *The training of the community hand pump mechanics should be well defined in the contract and, if possible, the contractor should spare one person from the team who will be doing the training both theoretically and practically for all the selected persons.*
